CANNULA TIP BREAKAGE INSIDE ADIPOSE TISSUE DURING LIPOSUCTION – A RARE CASE REPORT

Summary

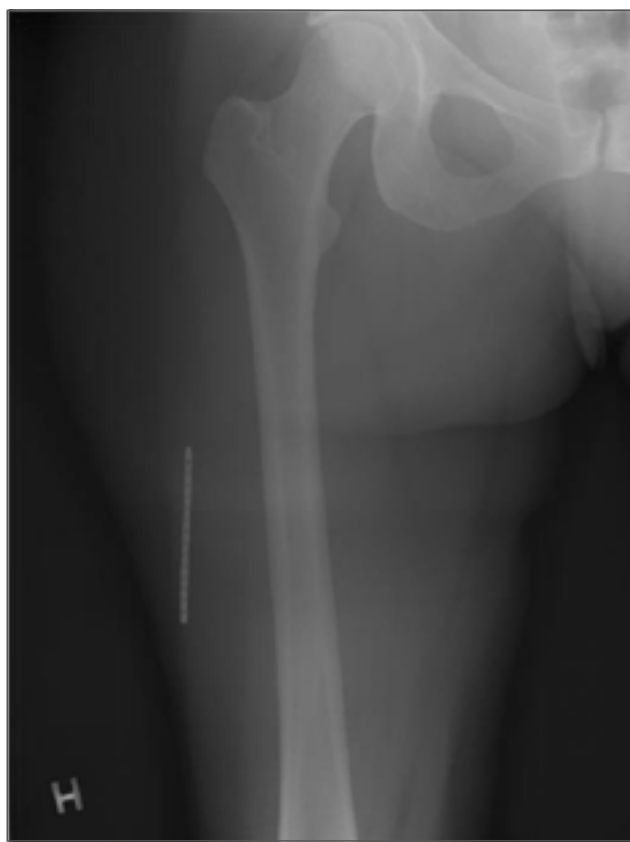
Figure 1. X-ray frontal view.

administration prior to liposuction of her right thigh followed by breast augmentation. After infiltration of 300 ml Kleins fluid with a standard infiltration cannula, upon retraction, the surgeon notices the tip of the infiltration cannula is missing. The surgeon tries to locate the tip of the cannula by palpation, but it is non-palpable. The patient is then transferred to Rigshospitalet, Plastic Surgery Department for removal of the cannula tip using radiographic imaging (Figs. 1-2). X-ray of the right thigh in two planes – frontal and lateral view – reveals a 7.8 cm cannula tip located dorsally and laterally from the femur, approximately 12 cm caudally from the right trochanter major, close to the skin near the insertion point.

Under general anesthesia the original insertion point is extended to one centimeter and using a c-arm the cannula is identified and removed in toto using a pean. Pre-operative 1.5 g cefuroxime is administered intravenously prophylactically.

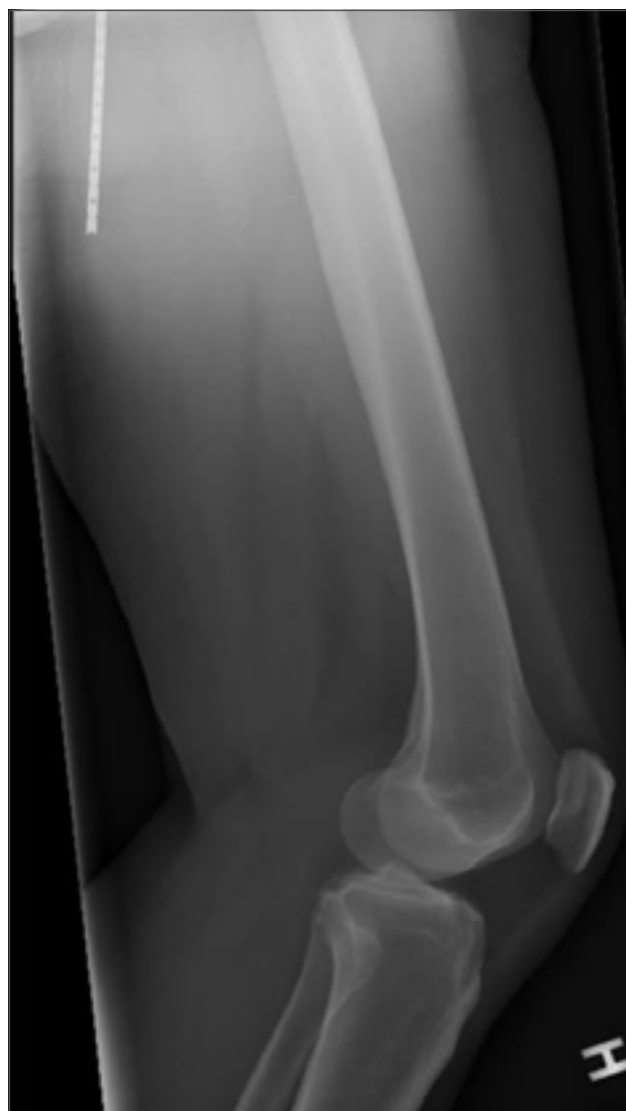
Figure 2. X-ray lateral view.

A broken liposuction cannula is a rare complication and the cannula in this study probably had a defect. The cannula is situated in the subcutaneous tissue and until it is removed it will do no harm to the patient compared to foreign bodies situated in the venous system – peripheral or central – which can have fatal complications for the patient. Liposuction is a safe procedure when performed by properly trained specialists following safe standard clinical practice. Should a rare complication such as the one in the present case occur, we recommend using x-ray imaging prior to surgery to establish location and depth and peri-operatively using a c-arm to confirm location upon incision.

Although constructed of good quality steel, cannulas used for infiltration are long, with thin walls and have several holes. These three elements make the cannula potentially at risk of damage or breakage. It would therefore be a safe procedure that the surgeon personally always does a pre-operative check of his instruments, checking their efficiency.
